DEPARTMENT OF TRANSPORTATION

Quality Assurance and Source Inspection

Contract #: 04-0120F4Cty: SF/ALA Rte: 80 PM: 13.2/13.9File #: 69.28**WELDING INSPECTION REPORT****Resident Engineer:**Pursell, Gary**Address:** 333 Burma Road**City:** Oakland, CA 94607**Report No:** WIR-001296**Date Inspected:** 15-Jan-2008**Project Name:** SAS Superstructure**OSM Arrival Time:** 1900**Prime Contractor:** American Bridge/Fluor Enterprises, a JV**OSM Departure Time:** 2330**Contractor:** Zhenhua Port Machinery Company, Ltd (ZPMC), Changxing Island **Location:** Shanghai, China**CWI Name:** Fu Guogang**CWI Present:** Yes No**Inspected CWI report:** Yes No N/A**Rod Oven in Use:** Yes No N/A**Electrode to specification:** Yes No N/A**Weld Procedures Followed:** Yes No N/A**Qualified Welders:** Yes No N/A**Verified Joint Fit-up:** Yes No N/A**Approved Drawings:** Yes No N/A**Approved WPS:** Yes No N/A**Delayed / Cancelled:** Yes No N/A**Bridge No:** 34-0006**Component:** 77 Meter Mock Up**Summary of Items Observed:**

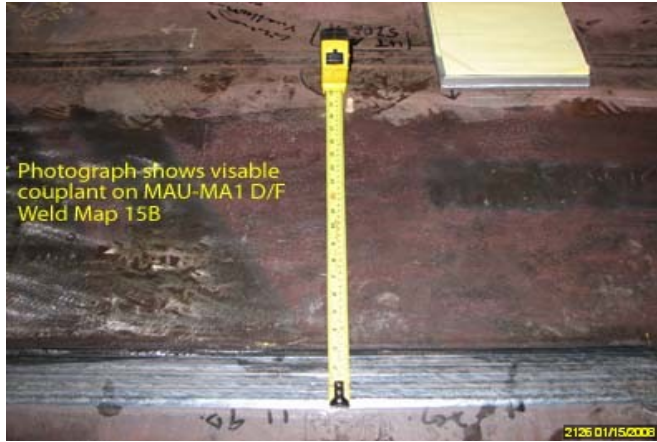
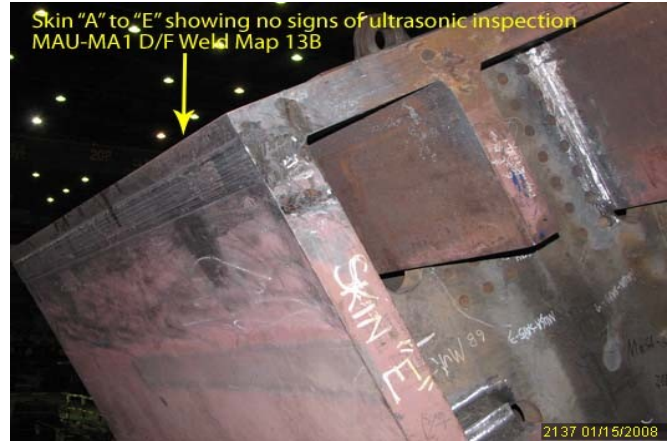
Bay 7- QA Inspector observed that no ZPMC Inspectors were present for a Quality Assurance (QA) observation of an ultrasonic inspection of completed welds on the 77 Meter Mockup. QA Inspector observed that ultrasonic couplant was present at weld joints MAU-MA1 D/F-13B, MAU-MA1 D/F-14B, MAU-MA1 D/F-15B and MAU-MA1 D/F-16B. No visible signs of couplant was observed at weld joint MAU-MA1 D/F-13B.
